NATIONAL TRANSPORTATION SAFETY BOARD

RAILROAD ACCIDENT REPORT

ILLINOIS CENTRAL GULF
RAILROAD COMPANY
FREIGHT TRAIN DERAILMENT
HAZARDOUS MATERIAL RELEASE
AND EVACUATION
MULDRAUGH, KENTUCKY
JULY 26, 1980

NTSB-RAR-81-1

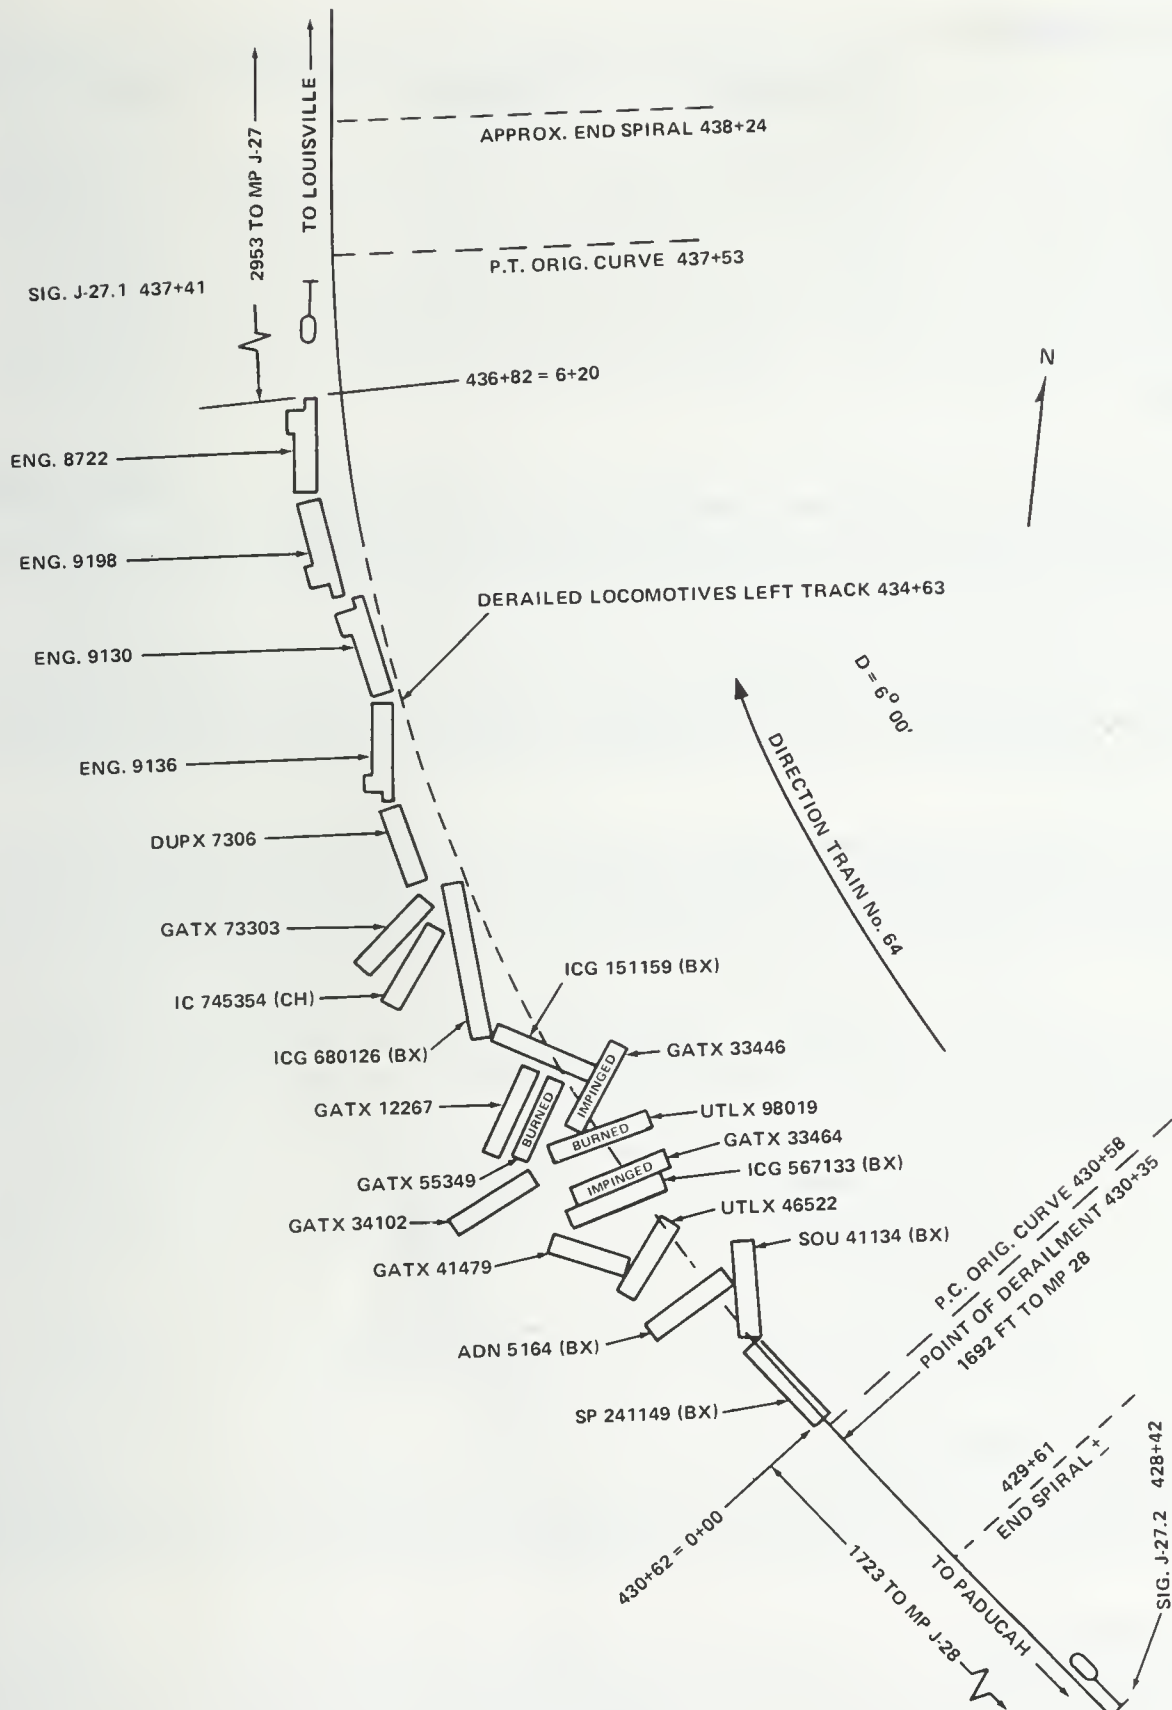
Figure 1.—Plan View of Accident

The following 17 cars were derailed. (See figure 1.) Seven were tank cars containing hazardous materials. Six of the tank cars carried vinyl chloride and one contained chlorine. Both vinyl chloride and chlorine produce toxic fumes when released to the atmosphere. Two of the tank cars of vinyl chloride were breached. The pressurized compressed gas escaped and formed a gas cloud around the derailed equipment.

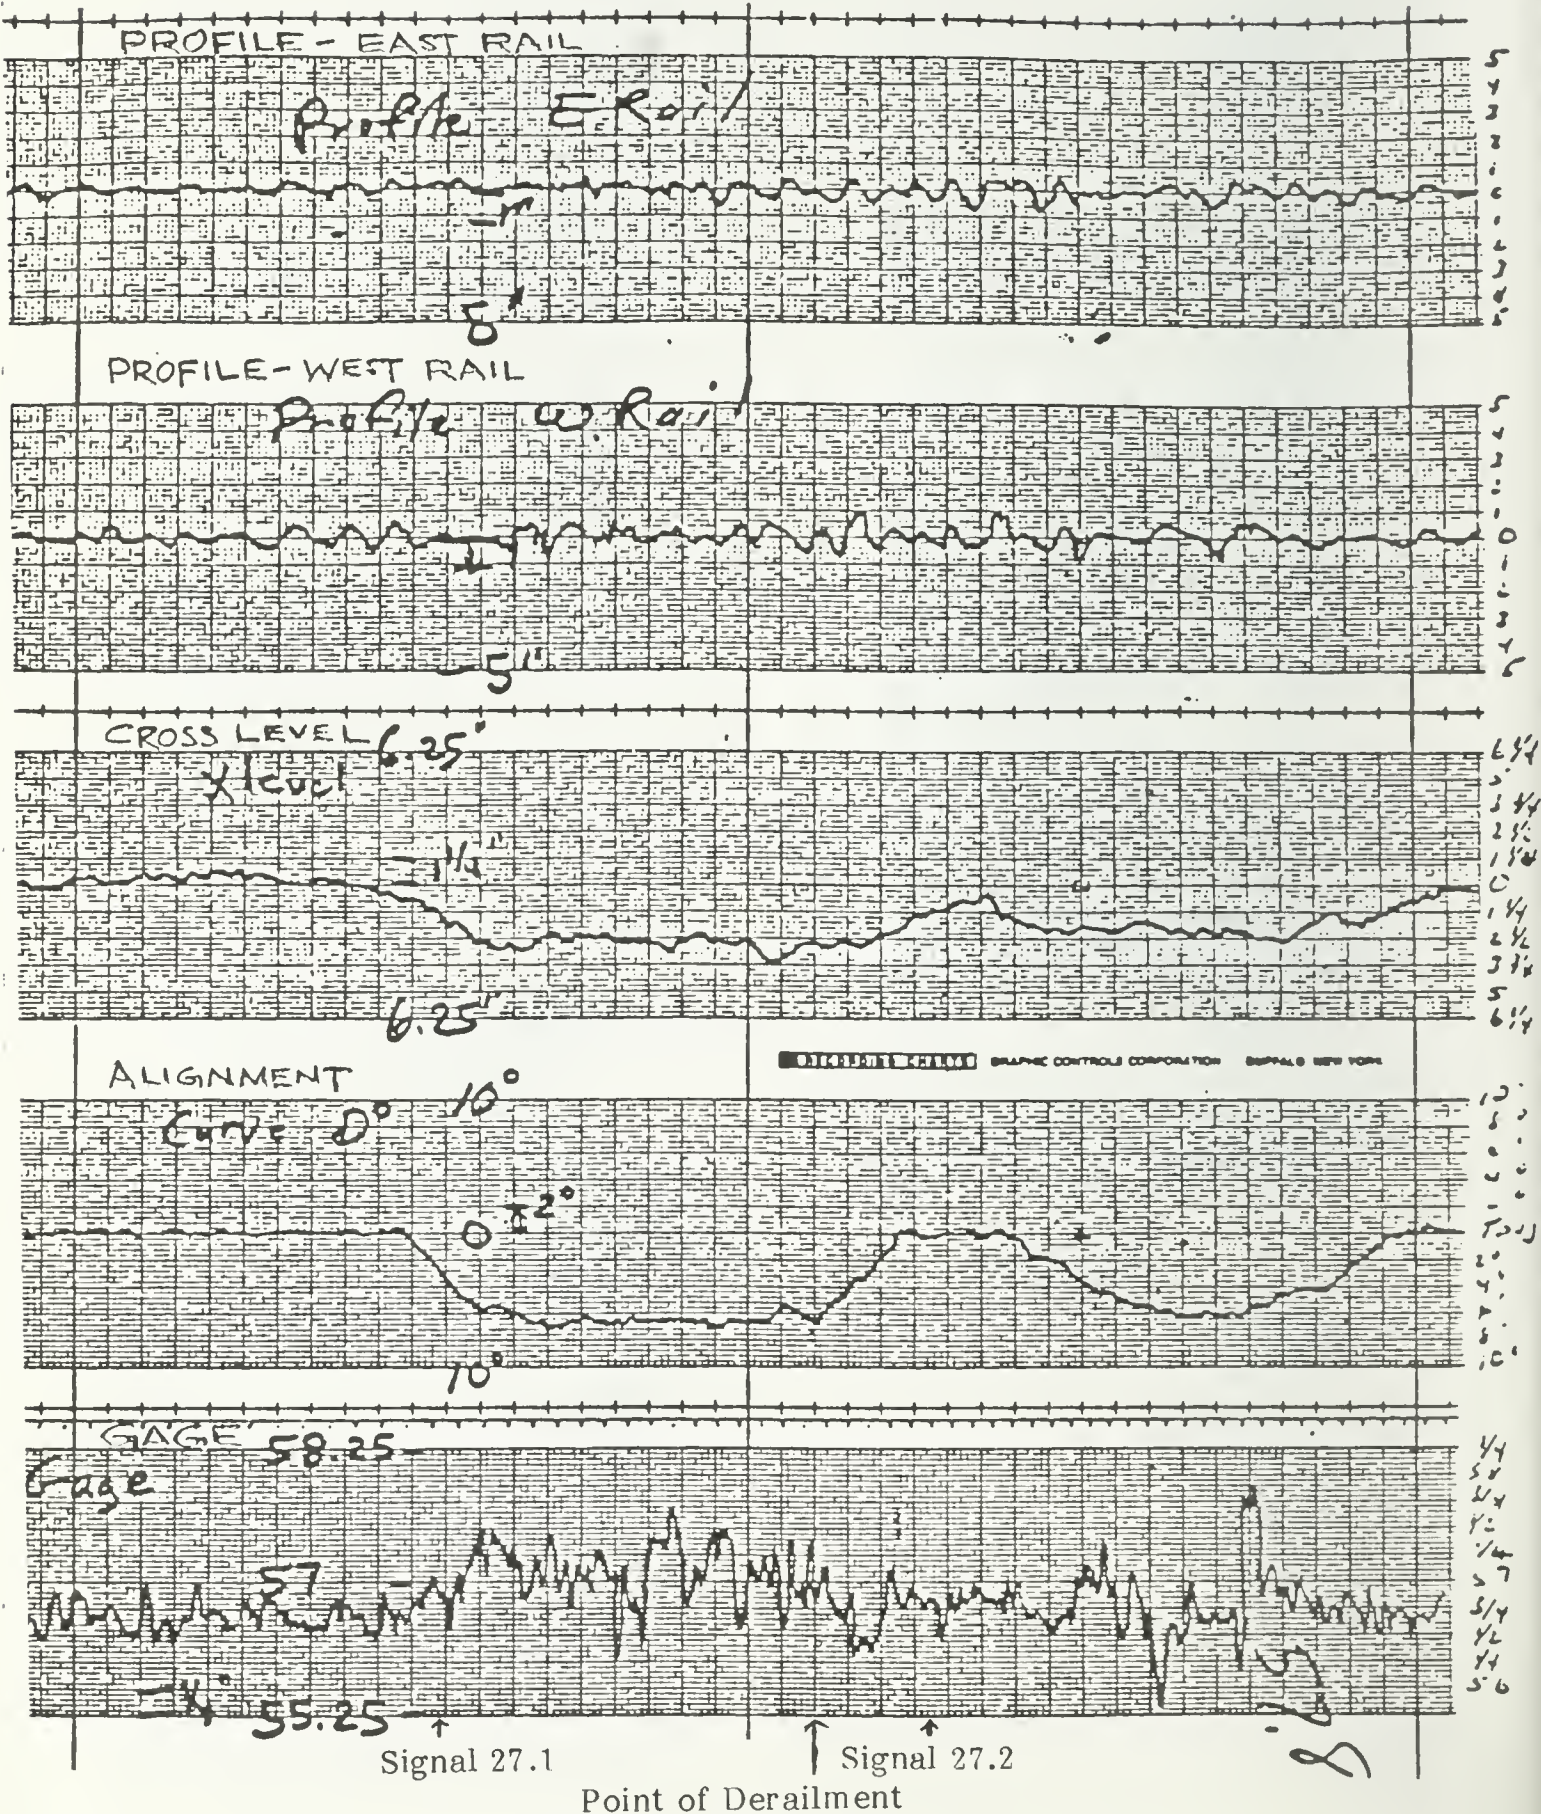
APPENDIX D
FRA GEOMETRY TAPE,
DECEMBER 14, 1979
ICG TRACK, MP 27 TO 28

The track was supposed to be maintained to meet the Federal Railroad Administration's (FRA) track safety standards for Class 3 track. (See appendix C.) An FRA geometry car was last operated over the track on December 14, 1979. The survey (see appendix D) found that at the midpoint of the 6° curve, the track gage at a joint was 57.6 inches, which is 1.1 inches wider than standard gage of 56.5 inches. In the next curve, at milepost 27.9, the gage at a joint was 57.8 inches. According to the ICG, the excess gage locations were repaired to meet the standards for Class 3 track, which allow a maximum gage of 57.75 inches. However, there is no record of the repair. The survey also found that the curvature deviated from the designed 6° between 5°30' to 7°, that the superelevation of the curve deviated from the planned 2 1/2 inches up to 3 3/4 inches, and that the profile of the track ranged from 1/2 inch to 1 inch high and low through the curve. The curvature, superelevation, and profile deviations were within the tolerances established by the standards for Class 3 track.

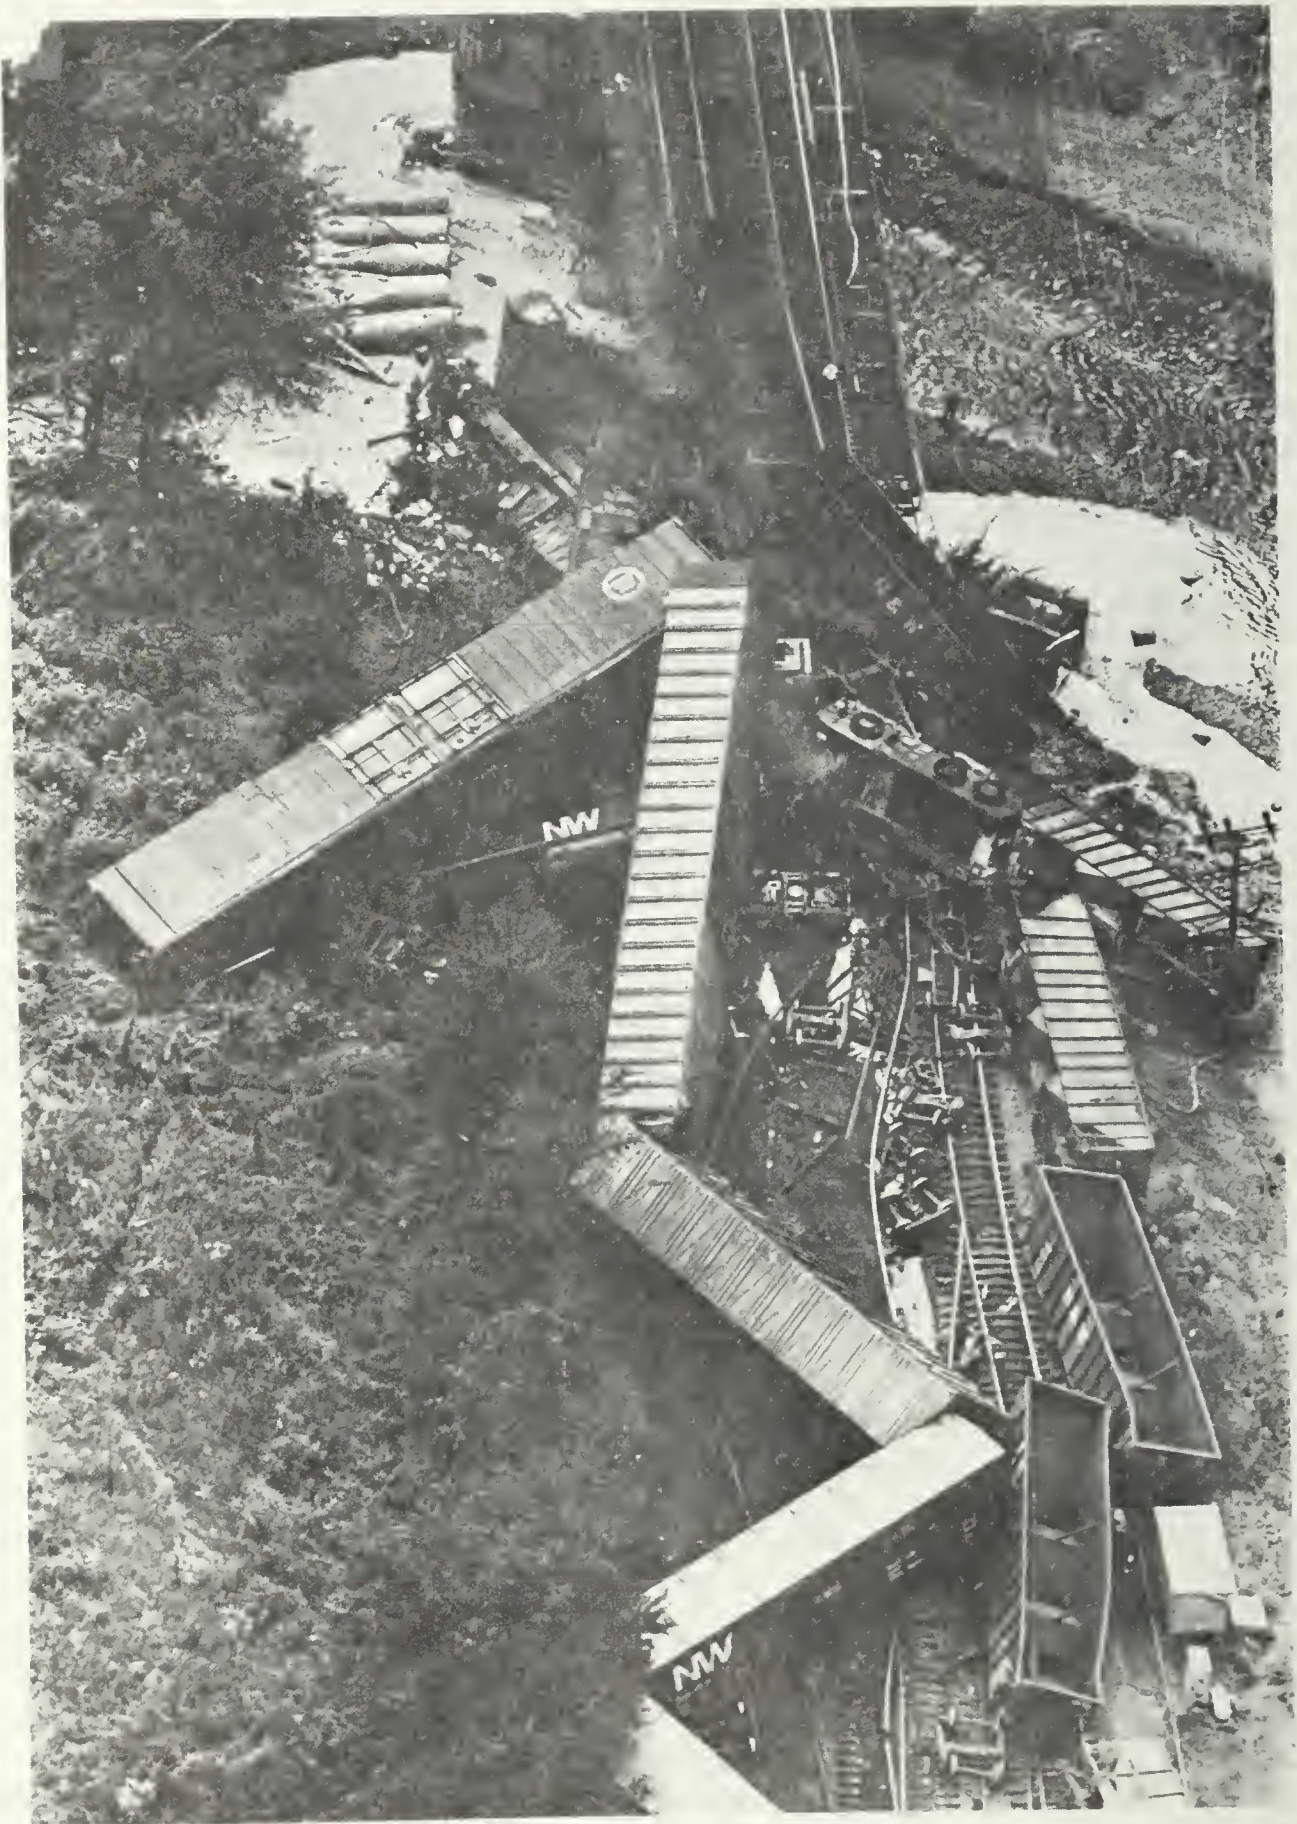
The first three locomotive units of train No. 86 were destroyed, and the fourth locomotive unit was damaged heavily. The first and second derailed cars sustained heavy damage, and the third through the sixth cars were damaged substantially.

Figure 1.--Side collision of train No. 86
(right) and Extra 1589 West (left).

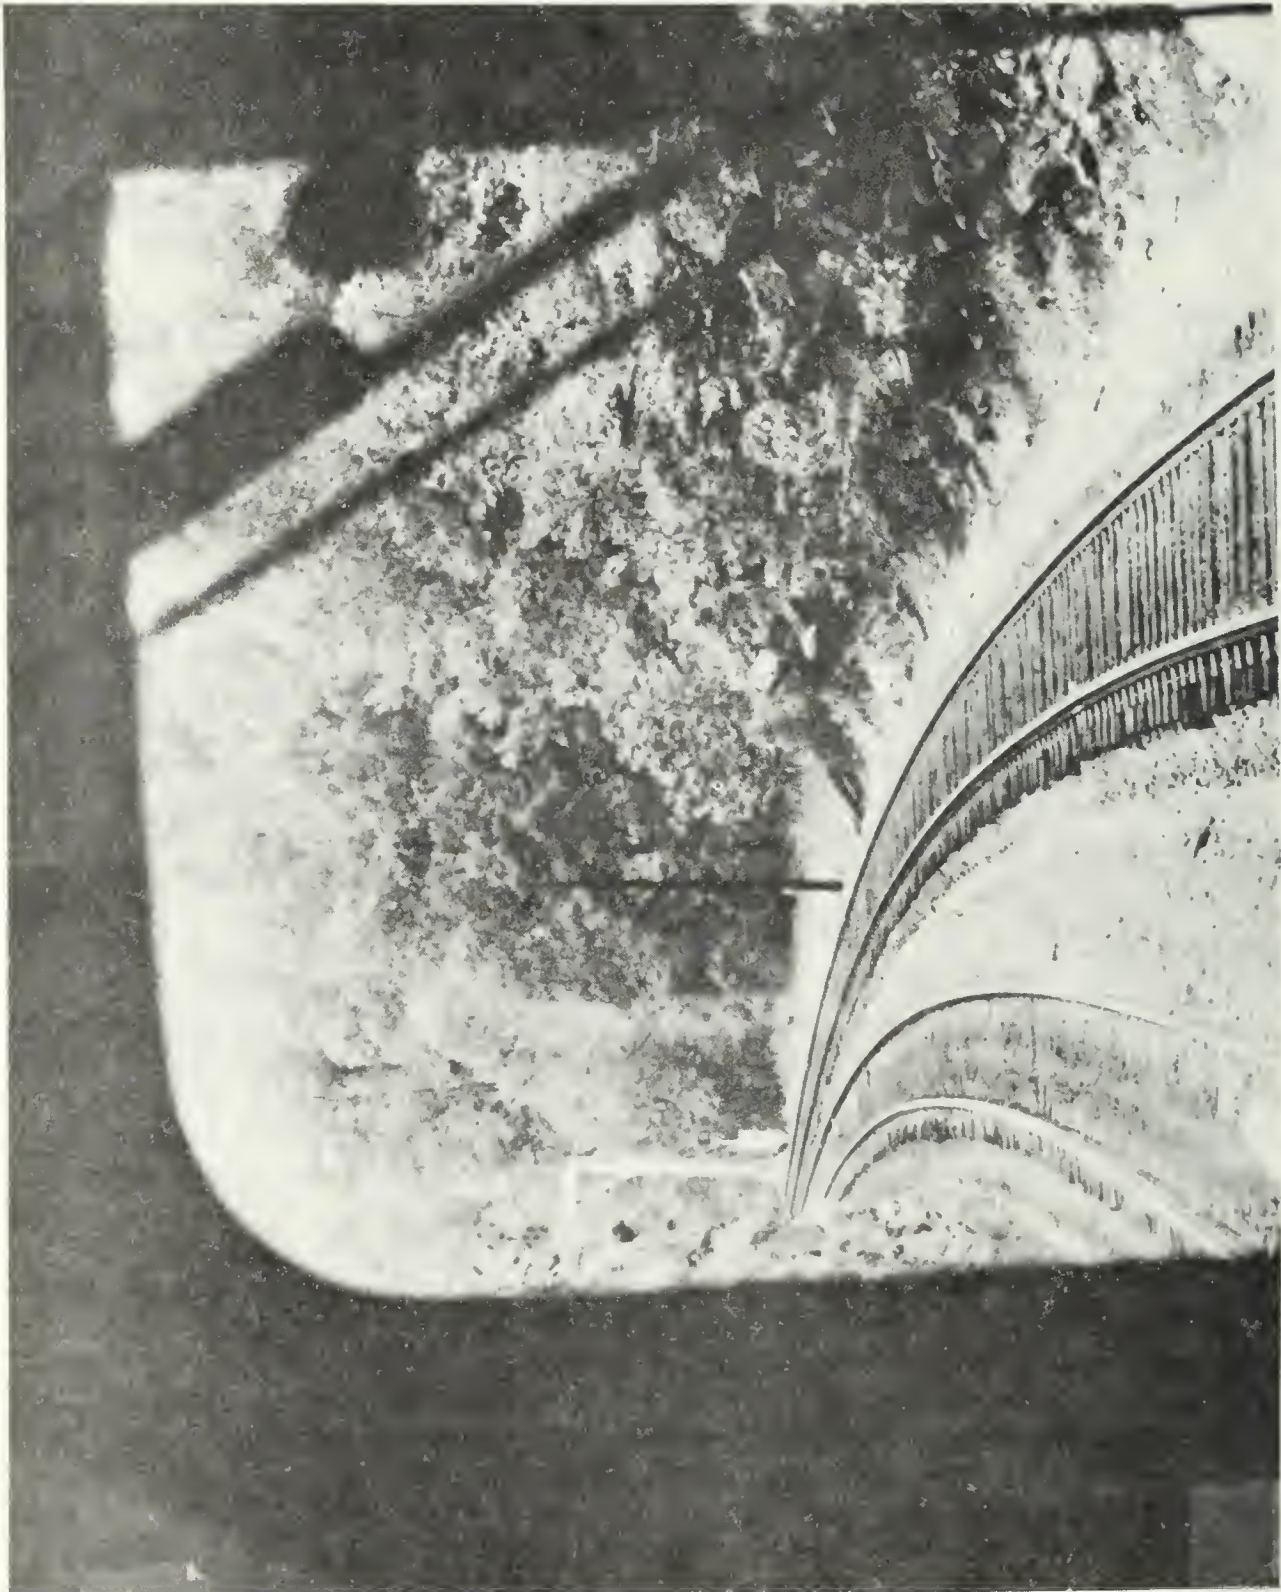
Lead Unit Operator's Seat Position South Side	Lead Unit Fireman's Seat Position North Side	Second Unit Side of Cab North South	
Available sight distance to "inspect train" signal at Mohegan = 1,046 ft	1,046 ft	1,051 ft	
Available sight distance to signal at Mohegan = 1,295 ft	1,295 ft	1,317 ft	926 ft
* Available sight distance to west end of Farm signal = 414 ft	438 ft	97 ft	405 ft
Available sight distance to east end of Farm signal = 457 ft	457 ft	448 ft	151 ft
Available sight distance to fouling point, east end of Farm (Westbound and middle track) = 637 ft	637 ft

Figure 5.--Eastbound operator's first available sighting of the "approach" signal at the west end of Farm.

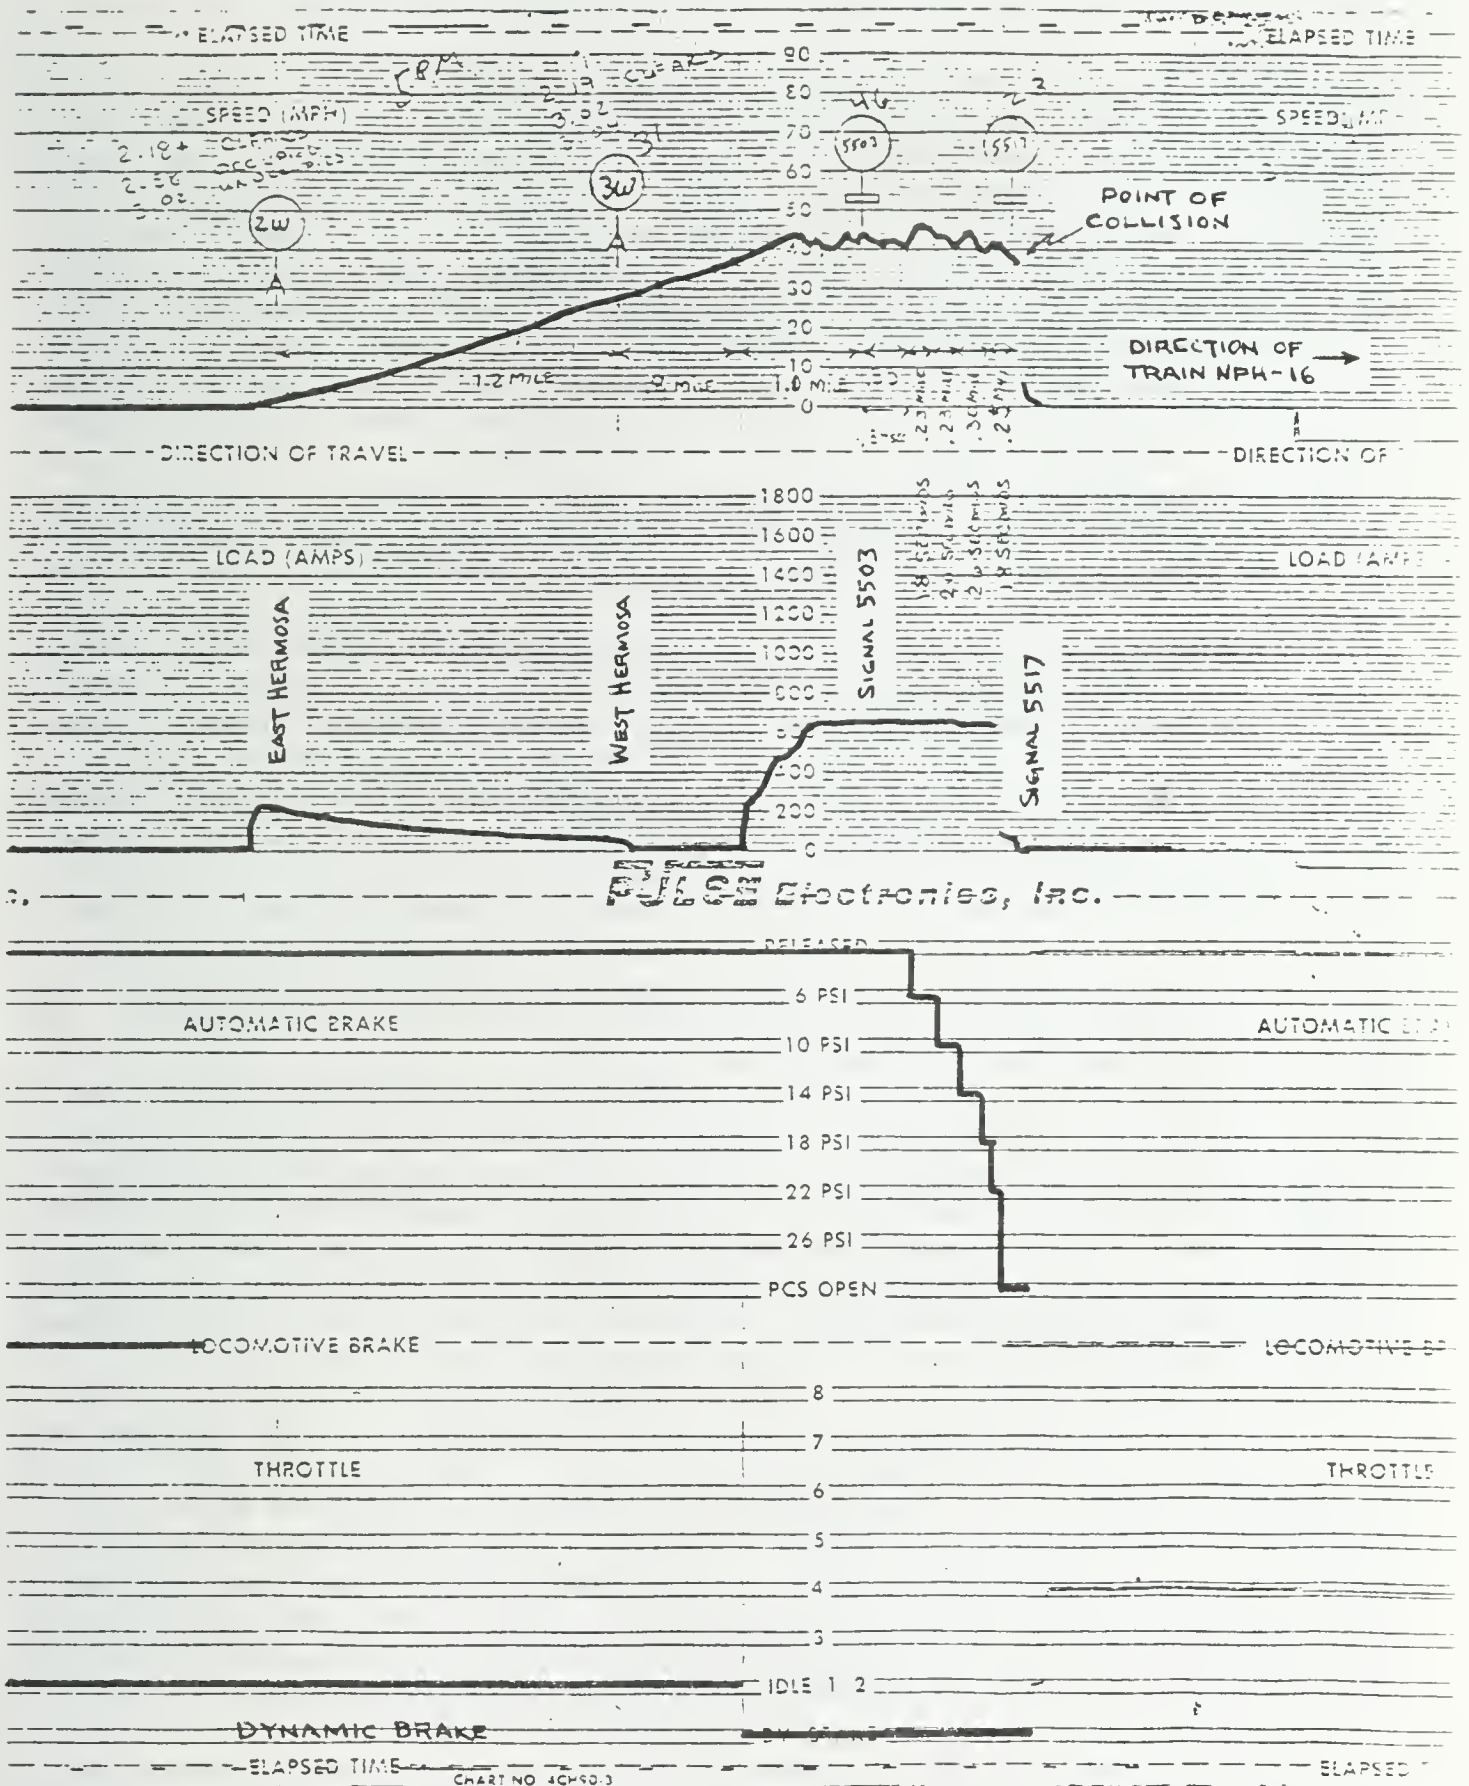
Figure 4.--Event recorder printout of NPH-16.

throttle was reduced to idle position. The train drifted for approximately 0.8 mile immediately after passing the signal at West Hermosa. Then dynamic braking was applied about 1 mile east of signal No. 5503 and progressively increased to full dynamic braking while the train accelerated to a speed of about 35 mph during the next 0.5 mile. At signal No. 5503, speed had increased to about 42 mph. After approximately 0.35 mile of continued dynamic braking west of signal No. 5503, a minimum brakepipe reduction was made. This was held for approximately 18 seconds. At this time, the speed was approximately 47 mph. Then an additional brakepipe reduction of 4 pounds, for a total of approximately 10 pounds, was made; this was held for approximately 20 seconds. Then an additional brakepipe reduction of 4 more pounds, for a total of approximately 14 pounds, was made and held for approximately 21 seconds. Then brakepipe reduction of an additional 2 or 3 pounds was made and held for approximately 5 seconds. The train's brakes were then placed into emergency about 0.25 mile east of signal No. 5517 while the train's speed was approximately 40 mph. The train continued in emergency for approximately 18 seconds, at which time there was a total loss of speed signal on the event recorder, which would indicate the point of impact.

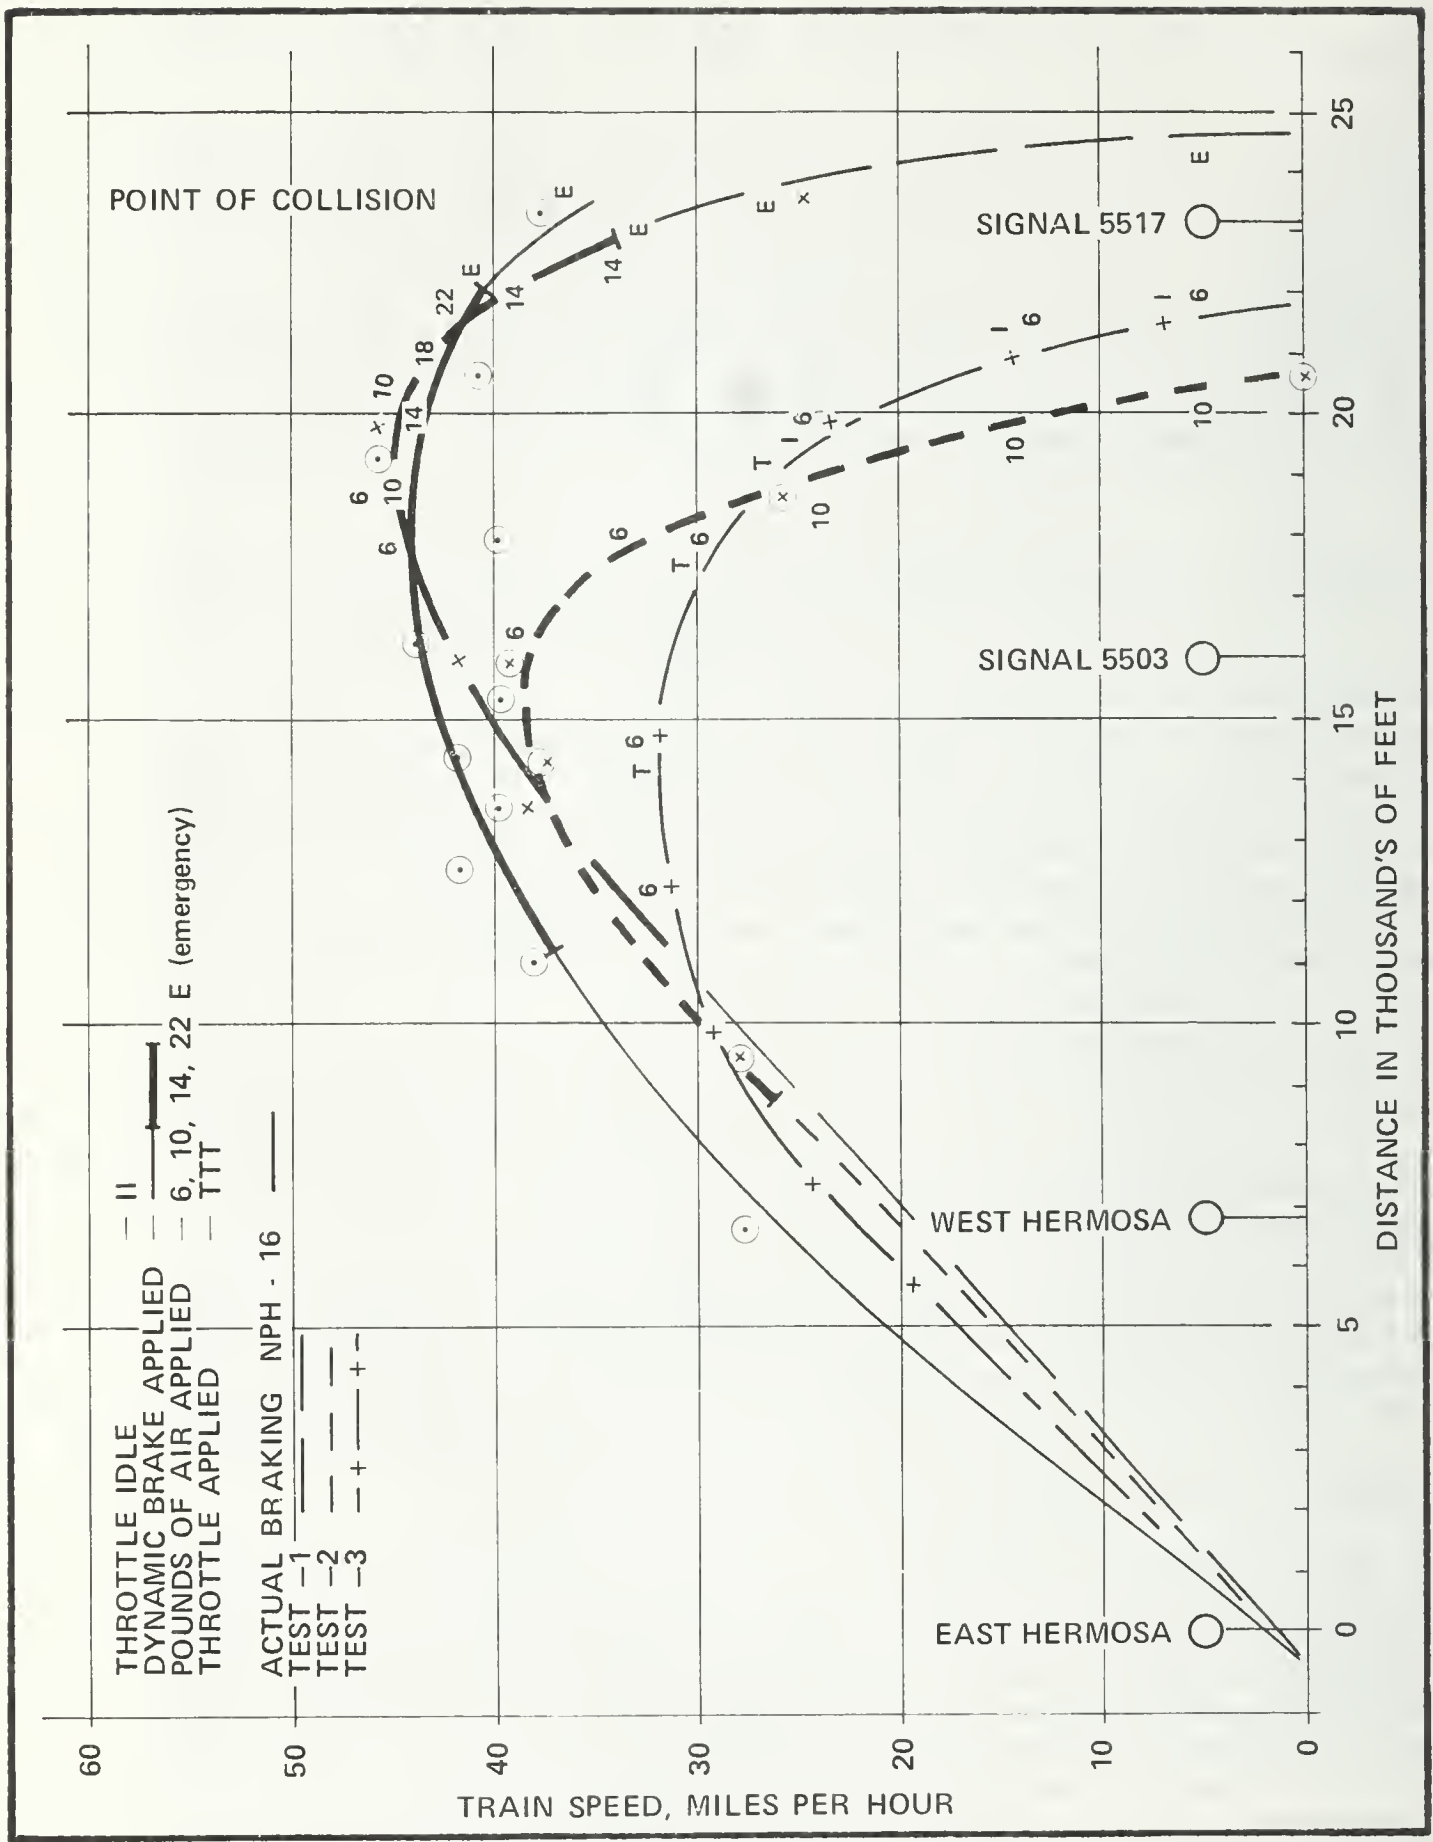
A second test was made to determine how the train would react if the dynamic brake was tested for effectiveness between East and West Hermosa, then later applying the dynamic brake to prevent passing signal No. 5503 at a speed not exceeding 40 mph, and immediately applying the airbrakes to reduce to a speed of 30 mph prepared to stop for signal No. 5517. After the test train was started at East Hermosa, the dynamic brake was applied about 0.25 mile west of the signal at West Hermosa at a speed of 28 mph. The speed was controlled with the dynamic brake in 7th position, and a 6-pound brakepipe reduction was made while the train passed signal No. 5503 at 40 mph. The speed decreased from 40 mph to 26 mph in 2,490 feet and then another 4-pound brakepipe reduction was made, increasing the total to 10 pounds. The lead locomotive unit of the test train stopped 4,980 feet west of signal No. 5503 and 2,194 feet east of signal No. 5517.

A third test was made to determine compliance with UP Superintendent's Bulletin A-9 of March 12, 1980, which was an additional listing to the tables on page 148 of UP System Timetable No. 3. The table required that trains of between 60 to 80 tons per operative brake, using airbrakes only, must not exceed 30 mph between Hermosa and Red Buttes. Tons per operative brake for the NPH-16 were obtained by dividing the train's tonnage (5,450) by the number of cars (69) in the train. After the test train was started at East Hermosa, the engineer allowed the speed to increase to 30 mph; about 0.4 mile west of the signal at West Hermosa, a 6-pound brakepipe reduction was made. The train, with the brakes applied, passed signal No. 5503 with the throttle in 6th position; while moving at 32 mph, the

Figure 5.--Stopping distance tests of test trains.

throttle was gradually reduced to idle, 3,960 feet west of signal No. 5503. The train stopped in 2,000 feet with the lead unit 1,214 feet east of signal No. 5517.

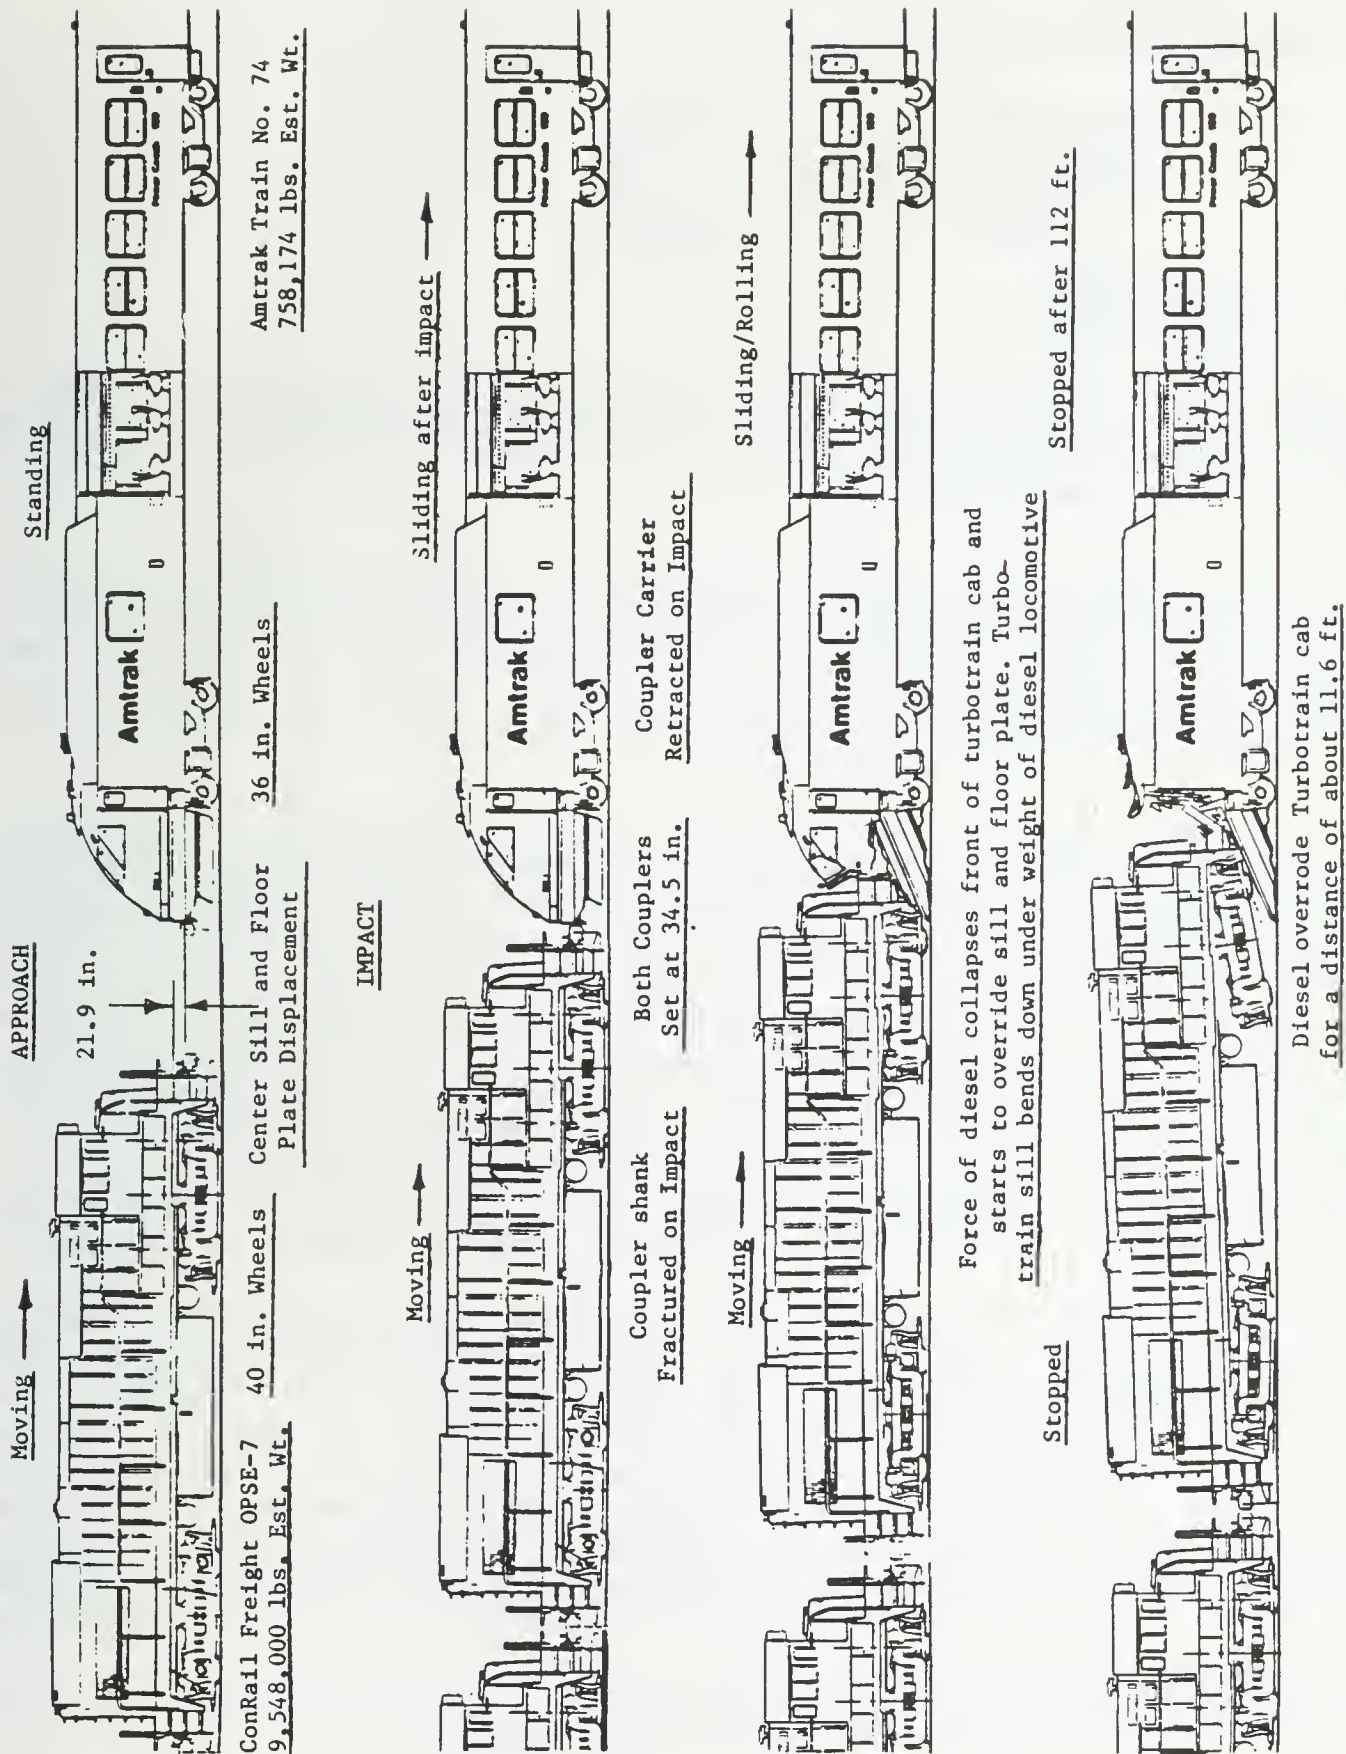
Damage to OPSE-7 was limited to the derailed lead locomotive unit. The front end coupler was broken and the front deck, handrails, and side steps were bent, torn, and twisted. The short hood was forward and it was crushed inward.

The operating cab of the power club car of train No. 74 was destroyed because of the 10-mph impact. All floor or deck mounted equipment was torn or sheared off. The other cars in the train sustained minor structural damage.

Figure 2.—Diagram of impact of OPSE-7 and No. 74.

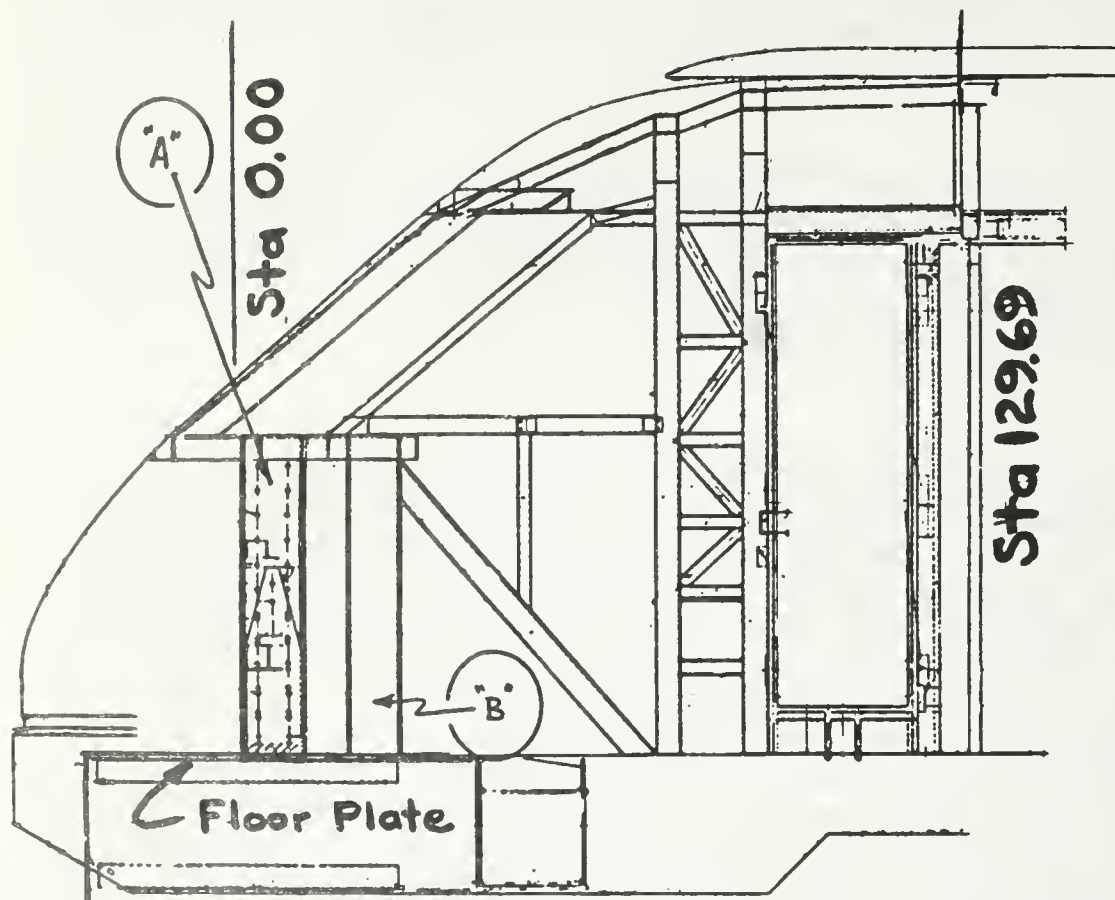
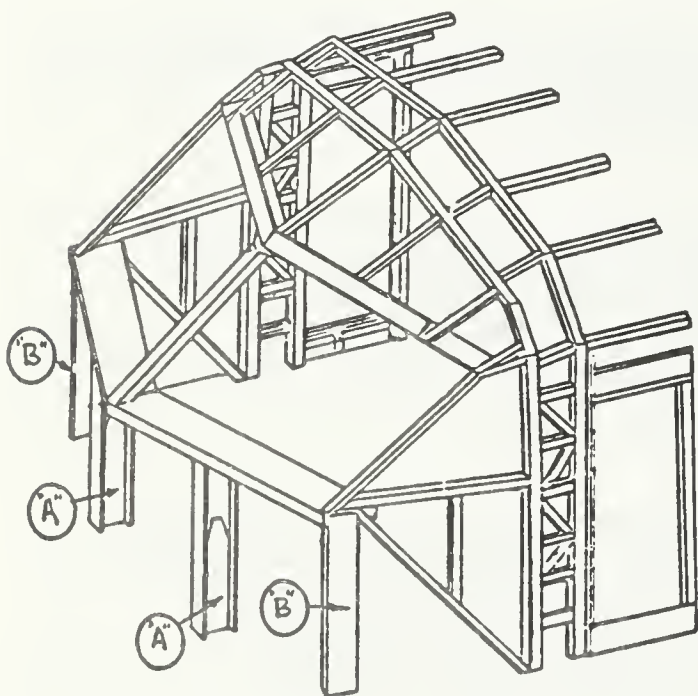
The operating cab of the power car had two 10-inch I-beam forward posts, identified by Amtrak as collision posts, (see figure 4 item "A"), welded to the floor. One end of the angled supports (item "B") was welded to the I-beams and the other end was welded to the floor. The forward posts (item "A") were tested in a mock-up configuration to meet the AAR specifications Nos. C-75 through -84, revised 1967. (See appendix H.) The height of the sill and floor plate on the power club car was 45.67 inches above the top of the rail.

"A" = Collision Posts (Center)
"B" = Collision Posts (Side)

Figure 4. -- Structural design of the engineman's cab front (turbotrain).

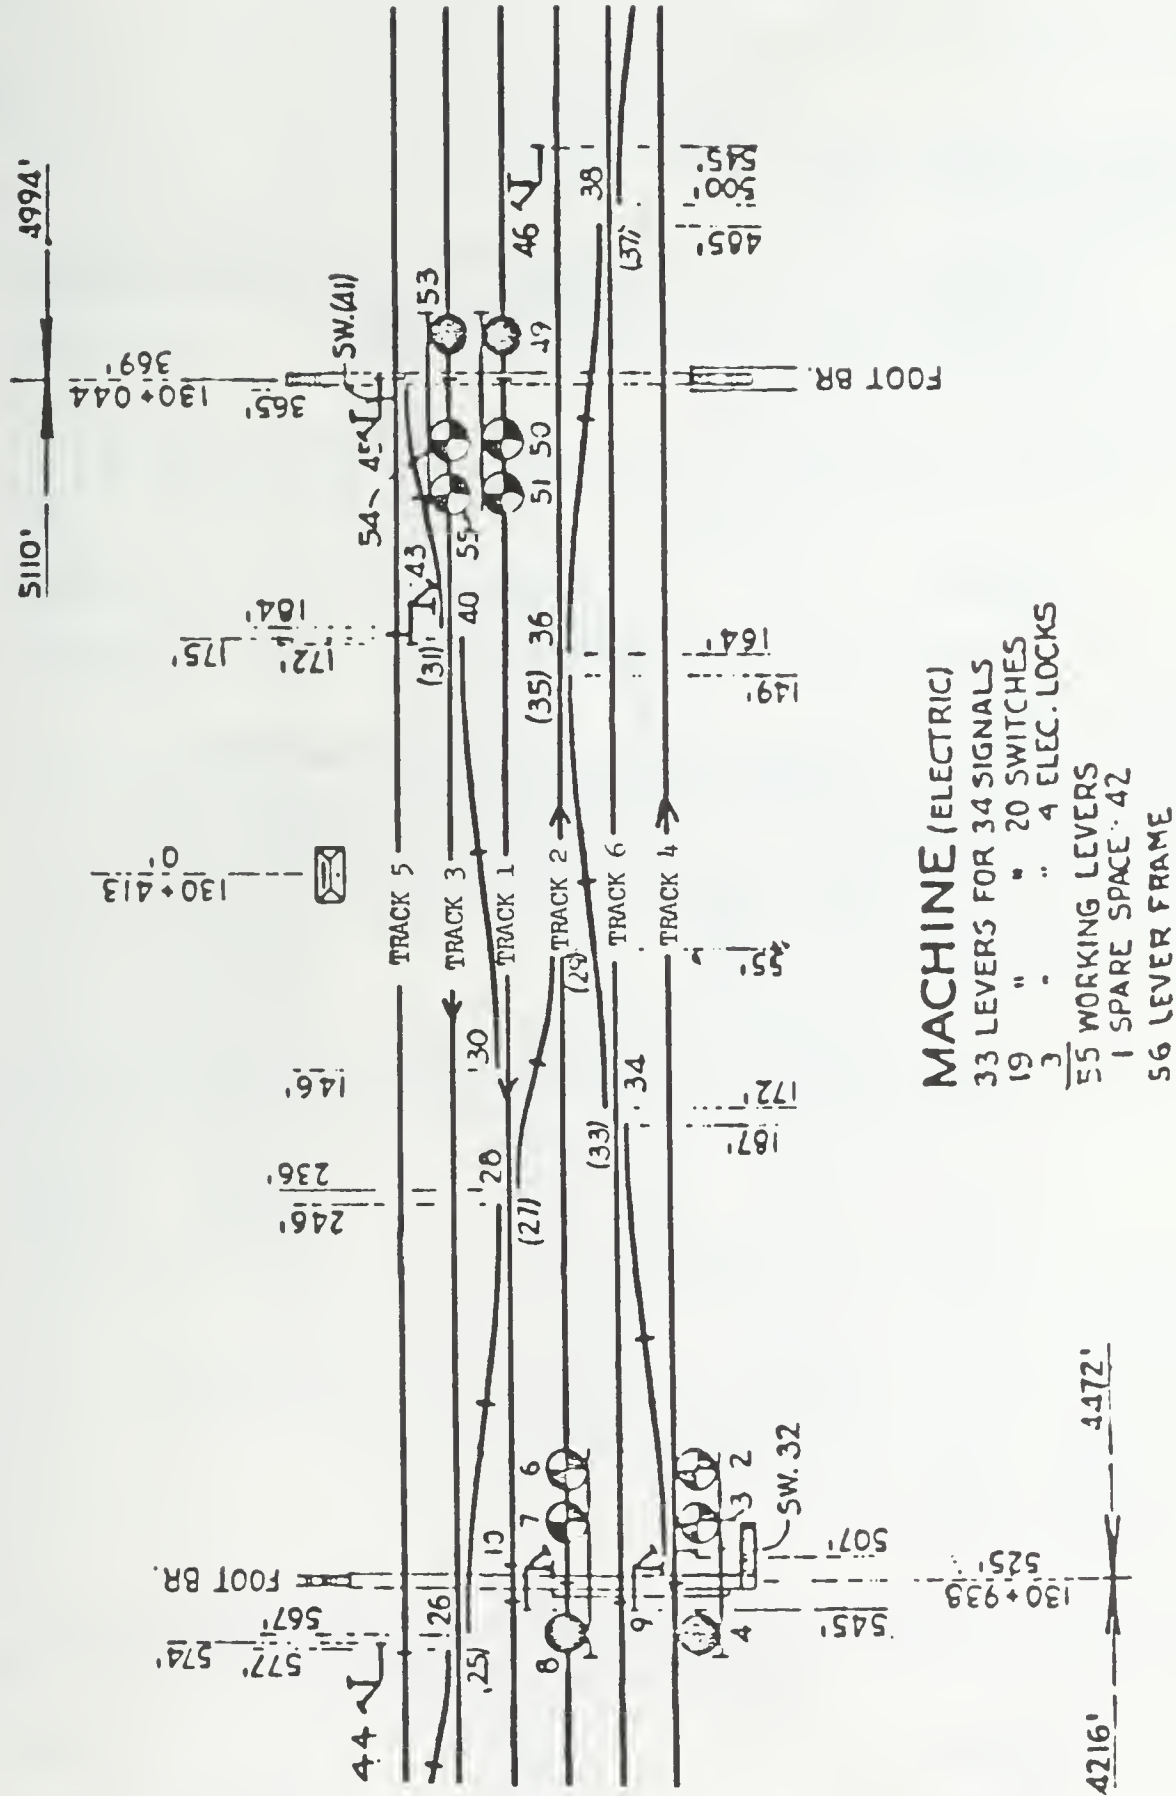
Figure 5.-- OW interlocking.

On the eastward signal mast for track No. 2 at OW interlocking, there was a fixture for a flashing letter "O", a train order signal; however, the signal had been electrically disconnected. A bracket for attaching a yellow flag or light, also a train order signal, to the tower building at OW was not accessible to the operator because the storm windows were nailed shut.
